Manhole Inspection Summary

Manhole # S29MM1023MH

Location Address: **302 COLDSPRING LN**

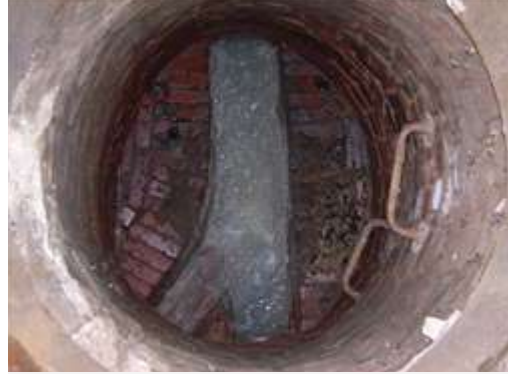
Top View

Corroded steps. Evidence of surcharge - Bench debris.

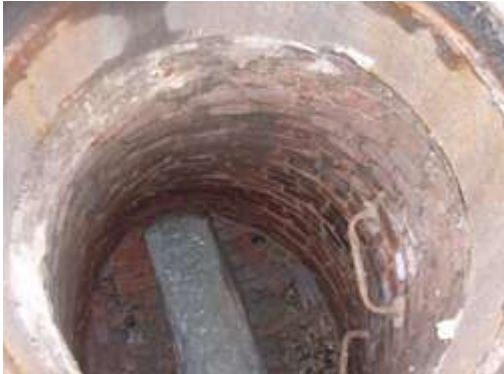
Defect

Frame leaks. Adjustment deterioration and infiltration.

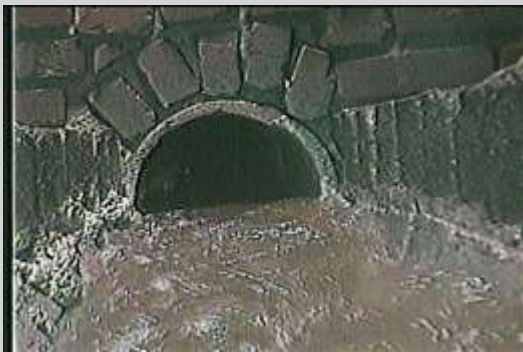
10 in. Circular Gravity Sewer Pipe Out @ 12 O'Clock

Barrel deterioration, loose brick and infiltration.

Infiltration: **Evidence** Pipe Seal Cond: **Broken**

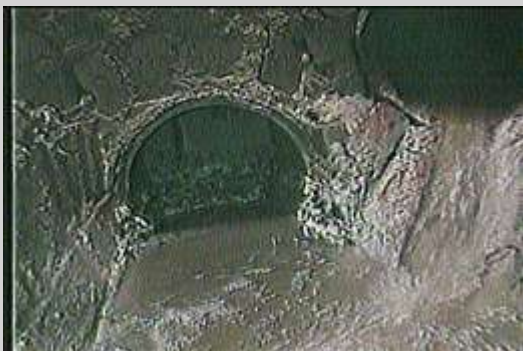
Pipe In @ 6 O'Clock

Plugged.

Connects To: **Stub connection / abandoned**

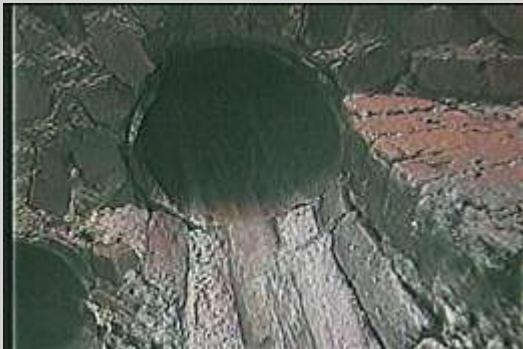
8 in. Circular Gravity Sewer
Pipe In @ 7 O'Clock

Channel deterioration.

Infiltration: **Evidence** Pipe Seal Cond: **Broken**
